STRUCTURAL INTEGRITY RESERVE STUDY

The Hillcrest No. 3 Condos Association, Inc.
940 Hillcrest Court Building 3, Hollywood, FL 33021

Prepared by: Gregorio Batista, PE, CGC, and Kristian Cano
Inspected on: July 18, 2024
Prepared on: July 24, 2024

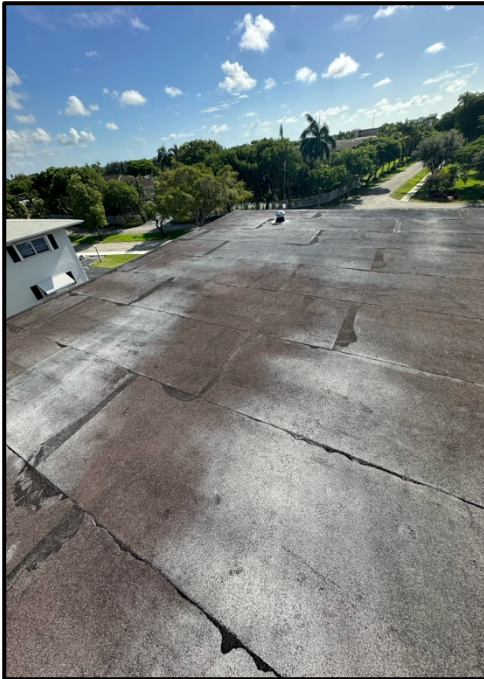
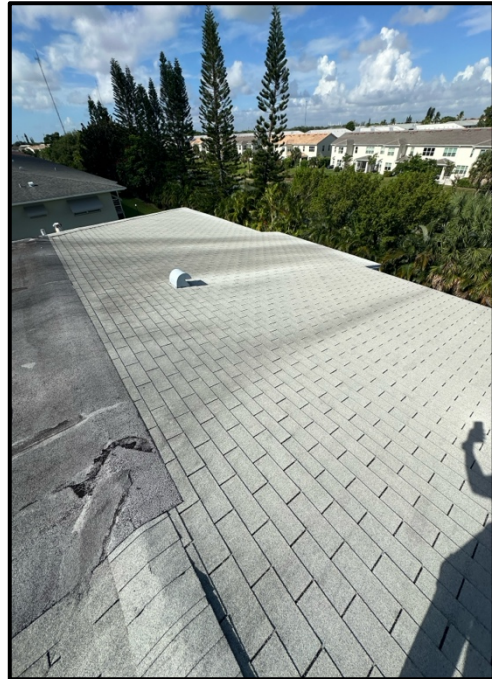
ROOFING SYSTEM

Condition: The appears to be in unsatisfactory conditions.

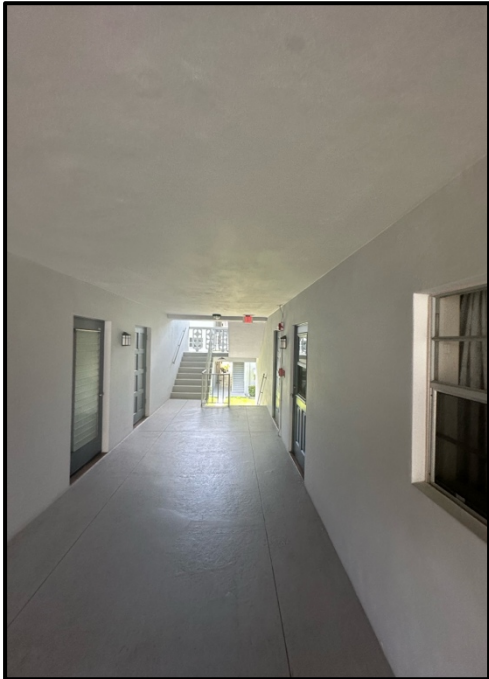
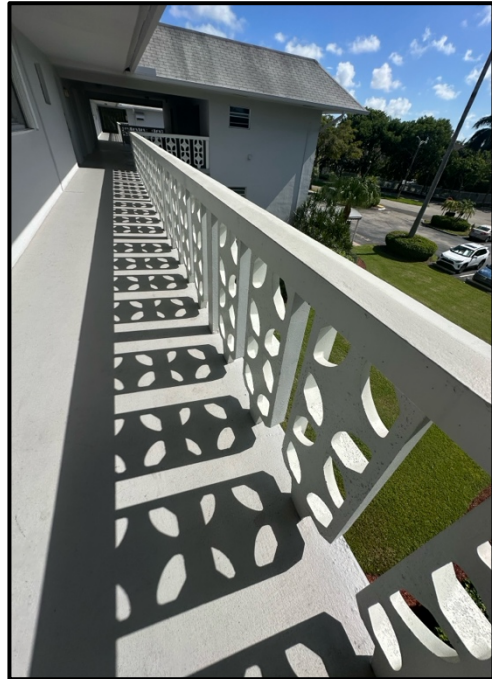
STRUCTURE, LOAD-BEARING WALLS, AND PRIMARY STRUCTURAL SYSTEMS.

Condition: The concrete framing and floor systems is in satisfactory condition.

Remaining Lifespan: Although concrete is a very durable material, due to the location's proximity to the coast, spalling due to rebar corrosion usually manifests before the concrete naturally deteriorates. It is important to note that it is rarely possible to visually inspect and examine all the concealed construction, nor should be generally necessary. Our conclusions are based upon our experience and conditions examined in the exterior typical structural members of the building. Refer to the table presented at the end of this report.

Estimated Cost of Replacement: Concrete repairs are typically done on a unit-price basis and should be repaired as damages appear. Refer to the table presented at the end of this report for our recommendation based on our experience and the size of the building.

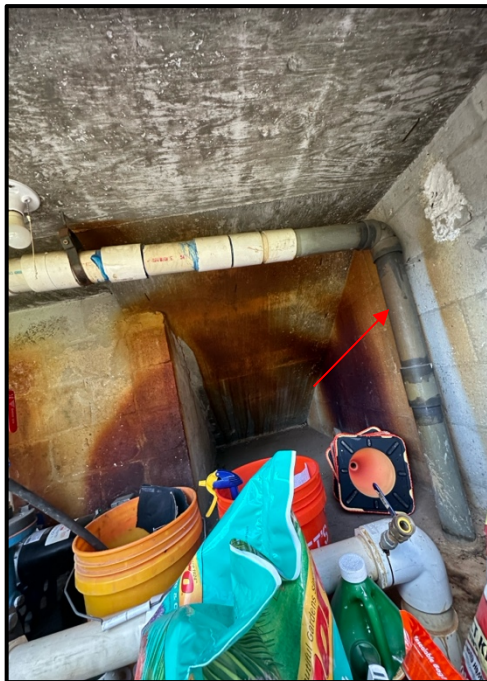
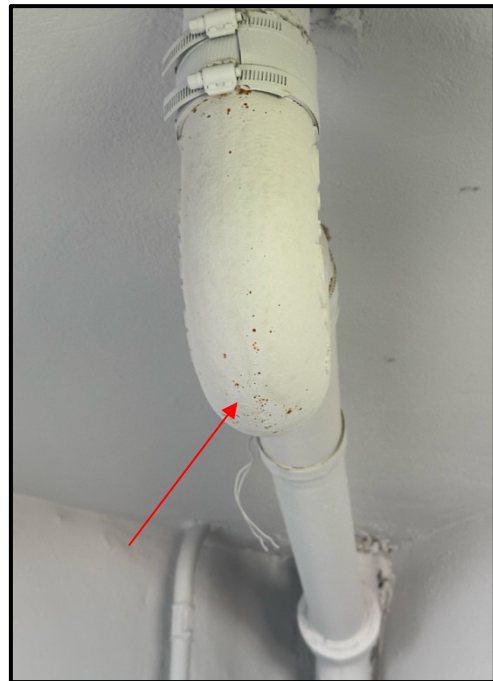
PLUMBING

Condition: The plumbing system in fair condition. It is important to note that it is rarely possible to visually inspect and examine all the concealed construction, nor should be generally necessary. Our conclusions are based upon our experience and deficiencies found in the visible and readily accessible areas.

Estimated Cost of Replacement: Plumbing lines and systems are typically not replaced in their totality but are repaired as items appear. See the table presented at the end of this report for our recommendation based on our experience and the size of the building.

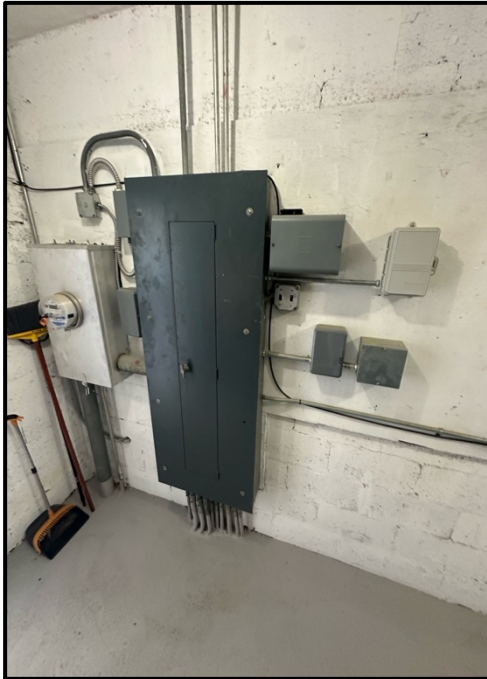
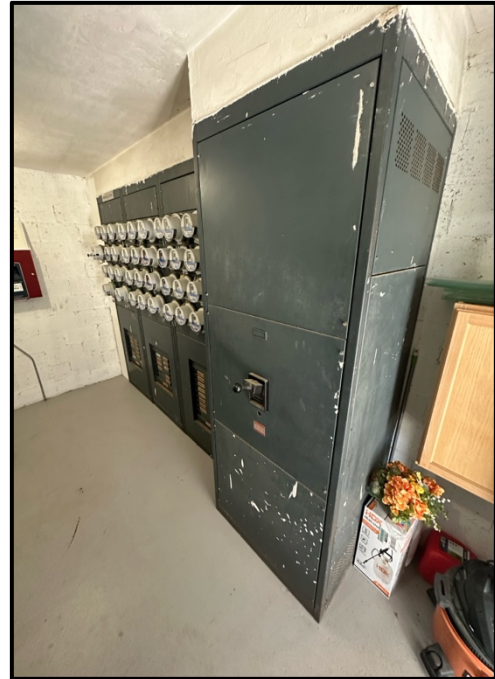
ELECTRICAL SYSTEMS

Condition: The electrical system(s) is in fair condition.

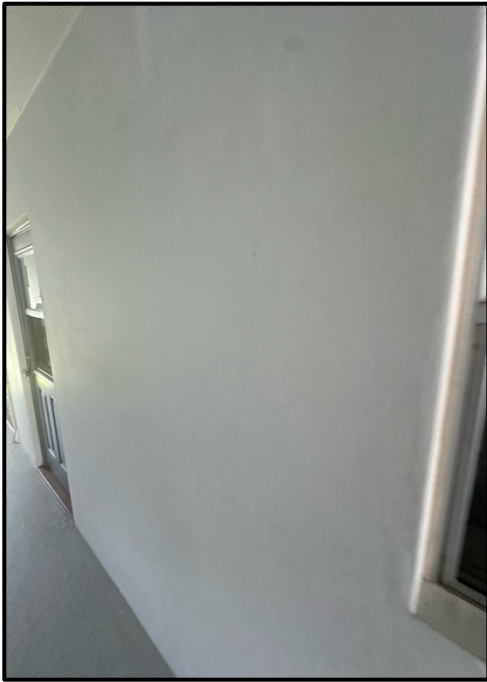
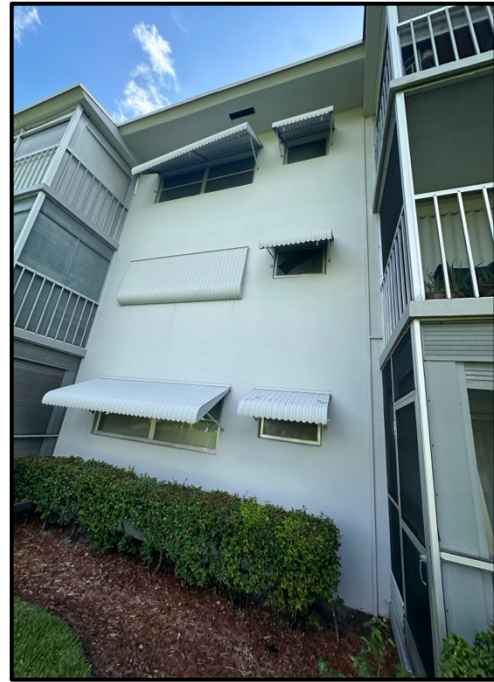
EXTERIOR ENVELOPE FINISH - STUCCO

Condition: The exterior stucco is in satisfactory condition. It is important to note that our conclusions are based upon our experience and deficiencies found in the visible and readily accessible areas.

Remaining Lifespan: Although the stucco is a very durable material, due to the location's proximity to the shore, spalling due to rebar corrosion usually manifests before the stucco naturally deteriorates. Refer to the table presented at the end of this report.

Estimated Cost of Replacement: The removal and replacement of all the stucco finish is rarely required. It is typically repaired as required in the building for general maintenance. Therefore, we assume that 20% of all exterior surfaces are required to be replaced at once. See the table presented at the end of this report for our recommendation based on our experience and the size of the building. (The exact amount of area needing replacement will be discretionary based on the actual future conditions and the desired appearance).

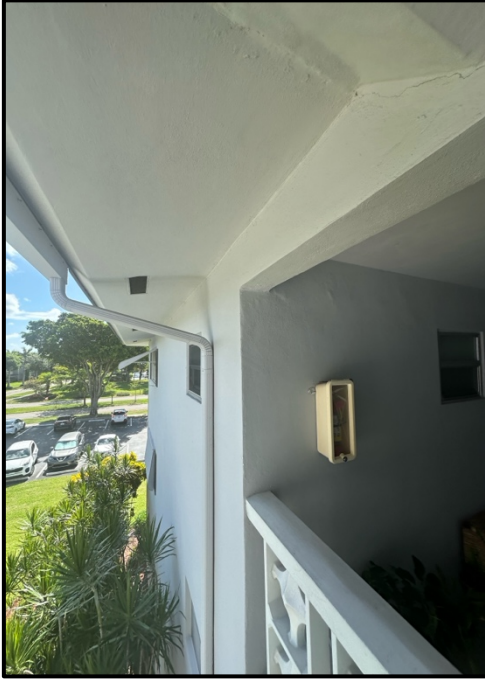
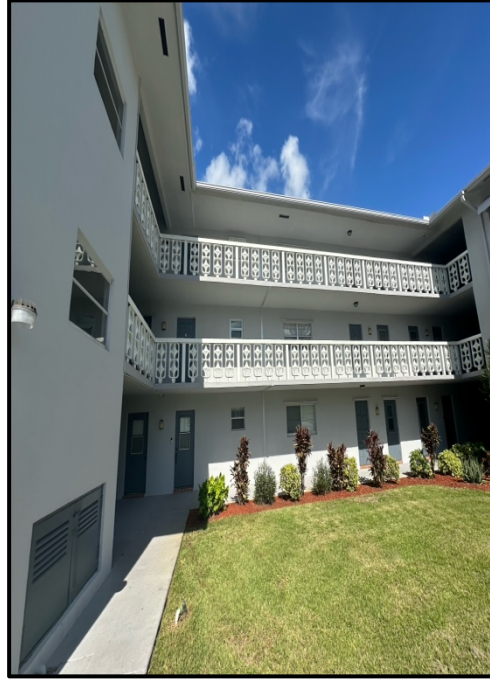
EXTERIOR FAÇADE – PAINTING & WATERPROOFING

Condition: The surfaces appear to be in good condition.

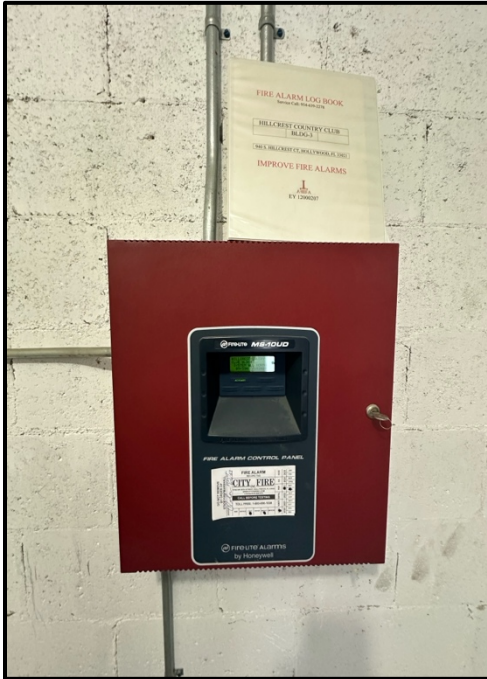
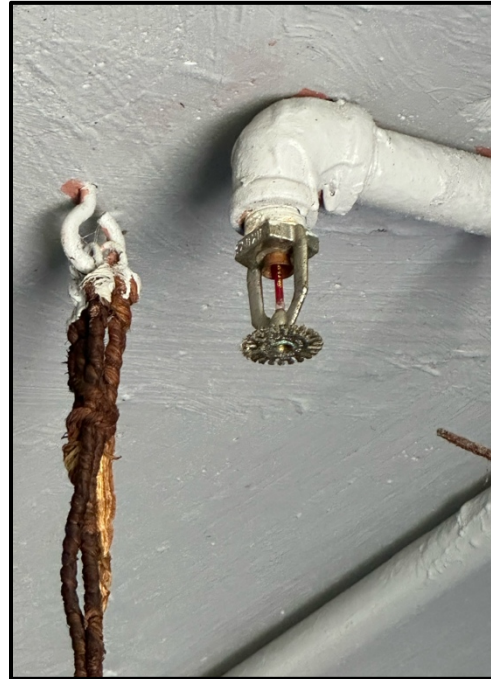
FIREPROOFING AND FIRE PROTECTIONS SYSTEMS

Condition: The fire protection systems appear to be in unsatisfactory condition.

Estimated Cost of Replacement: Fire protection systems such as the ones observed in the building are typically not replaced in their totality but are replaced as required. See the table presented at the end of this report for our recommendation based on our experience and the size of the building.

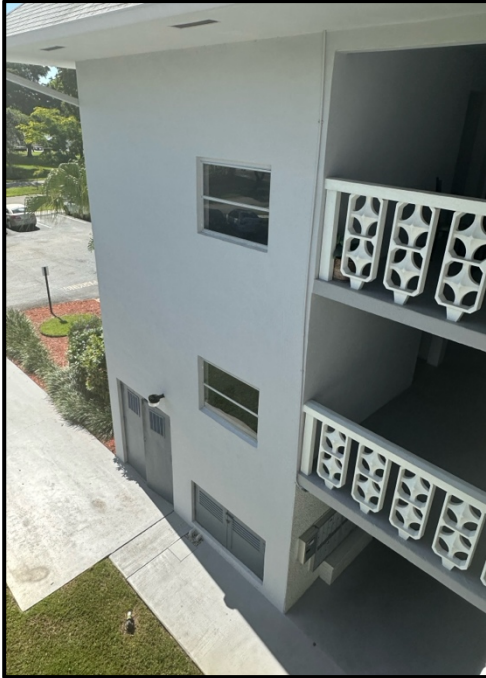
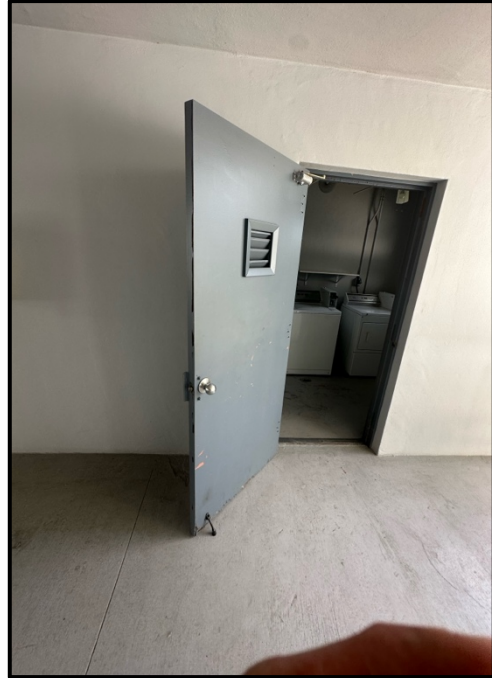
EXTERIOR WINDOWS & DOORS (COMMON AREAS ONLY)

Condition: The common area windows and doors appear to be in fair condition. The association is only responsible for the common areas. The units' windows and doors are the unit owner's responsibility.
